Re: Oversight Report for the Oversight Provided from 15 June through 9 August 2001  
Skinner Landfill, West Chester, Ohio

**REMEDIAL ACTION OVERSIGHT  
PERIODIC REPORT  
SKINNER LANDFILL  
WEST CHESTER, OHIO  
(15 JUNE THROUGH 9 AUGUST 2001)**

Document Control No. RFW114-2B-AJDC

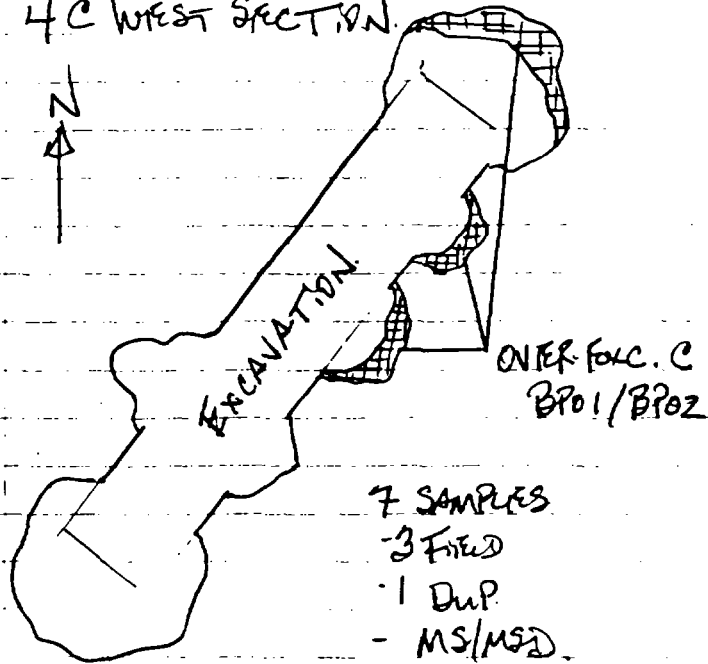
1635 PRO TERRA RAN INTO SATURATED SIG  
& HAVING PROBLEMS W/ SIDE WALL STABILITY.  
THE LOWER PORTION OF THE EXC. COLLAPSES  
SOMEWHAT DURING THE EXC WORK

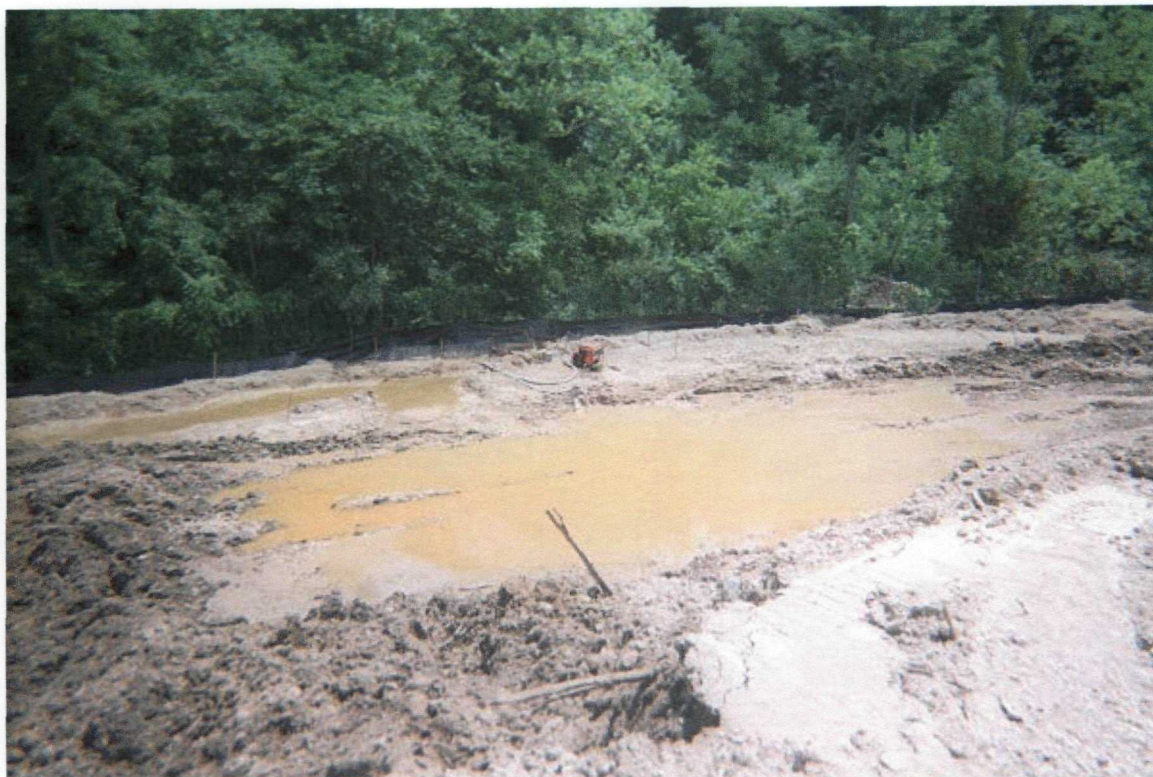
29 June 2001 - Pooled runoff and leachate near Interceptor Trench #2, looking southwest Skinner Landfill

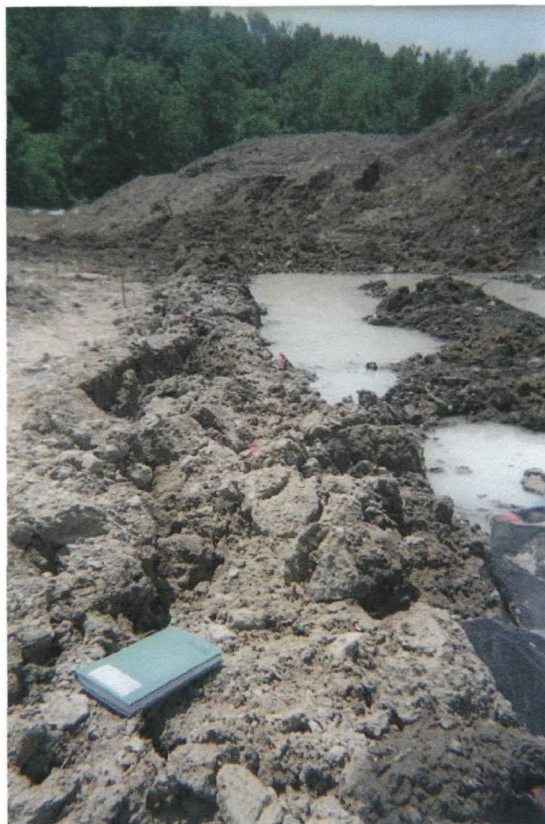
Construction of Interceptor Trench Number 2 (middle) was postponed due to construction problems. Soil fractures developed parallel to the slurry wall near Interceptor Trench Number 2 construction. It appeared that part of the slurry wall had fallen into the interceptor trench as a result of excavation, soil saturation, or general lack of trench wall stability. The cracks developed between stakes 5+70 and 6+40. Earth Tech, Pro Terra and Geo Solutions constructed an earthen berm near the soil fractures to prevent the bio-polymer from draining off site. The contractors speculated that the slurry wall is effectively retaining leachate, so much so, that the soil adjacent to the wall is saturated, possibly impacting the bio-polymer filter cake and stability of the trench. Ron Roelker (Project Engineer) said that Pro Terra would provide a Corrective Action Plan or Modified Work Plan by Monday afternoon 2 July 2001. The contractors subsequently moved equipment and supplies further west to begin work on Interceptor Trench Number 3. Construction of Interceptor Trench Number 3 began and was postponed shortly thereafter because of the amount of leachate coming through the trench side-wall. The trench was subsequently backfilled.

29 June 2001 – Soil fractures along Interceptor Trench #2, looking west, Skinner Landfill

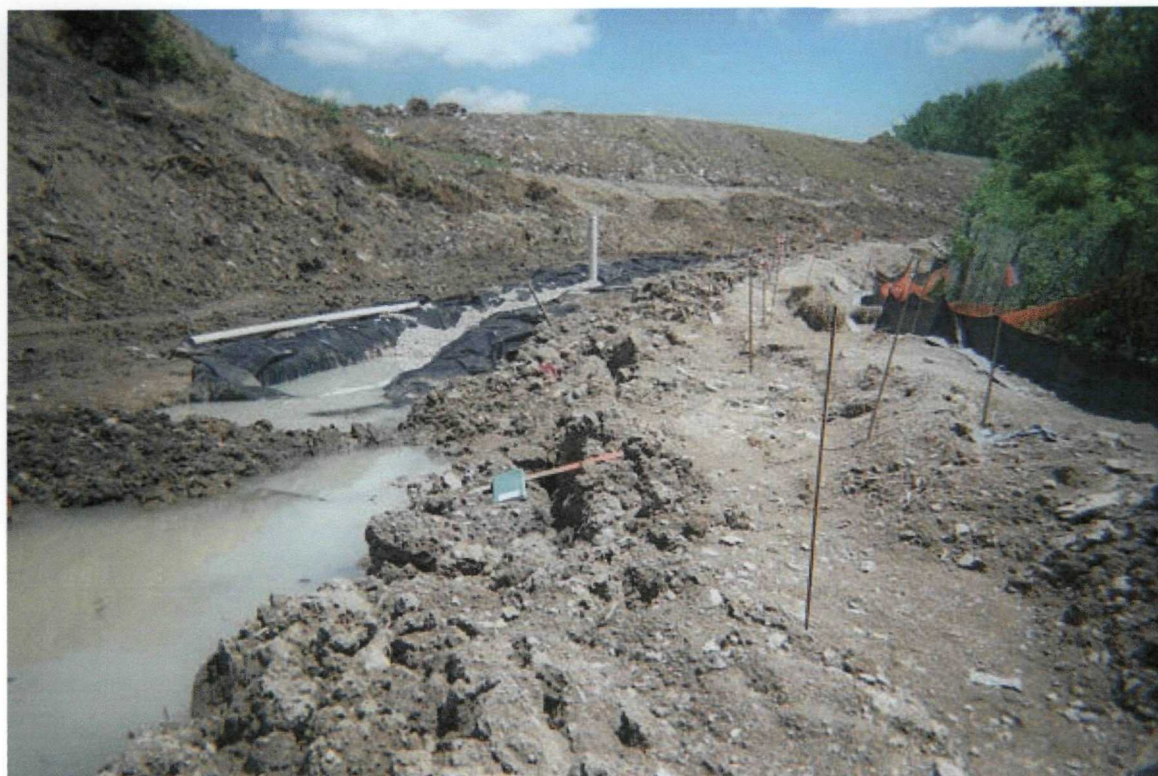
2 July 2001 - Soil fractures along Interceptor Trench #2, looking east, Skinner Landfill

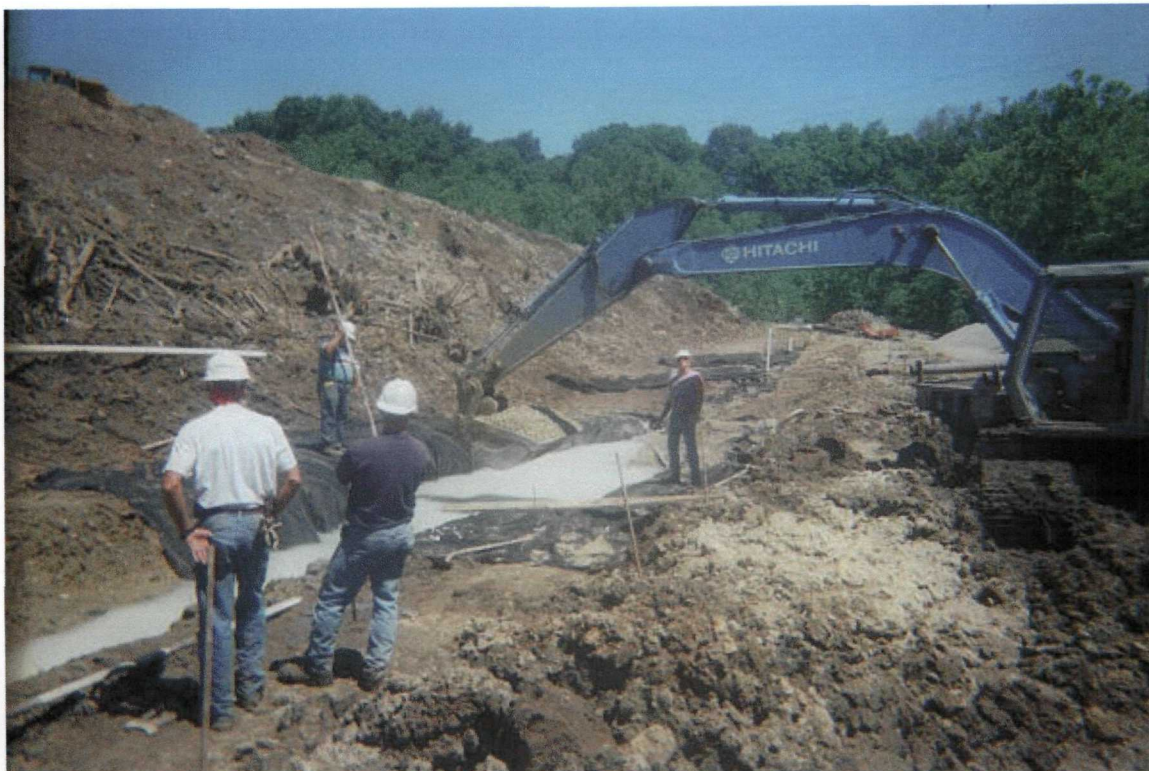
9 July 2001 - Working through saturated sand lenses at Interceptor Trench # 3, Skinner Landfill

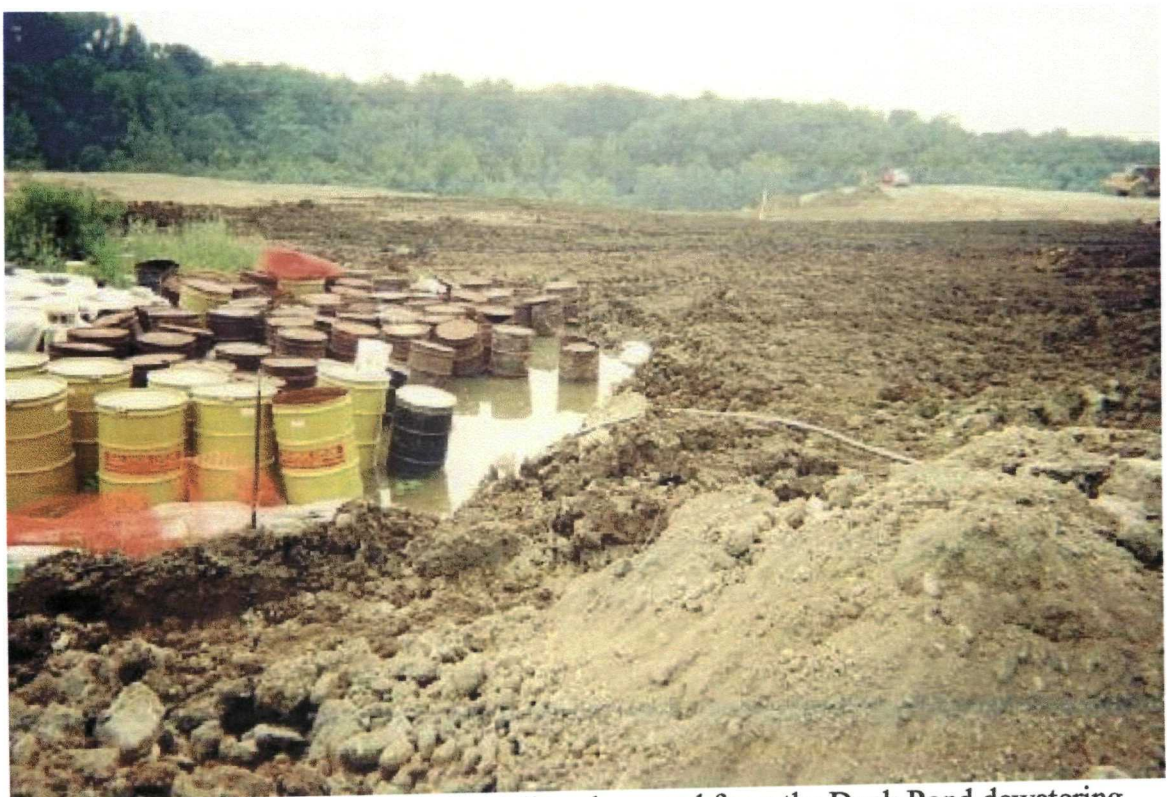
16 July 2001 - Drum staging area partially submerged from the Duck Pond dewatering, Skinner Landfill

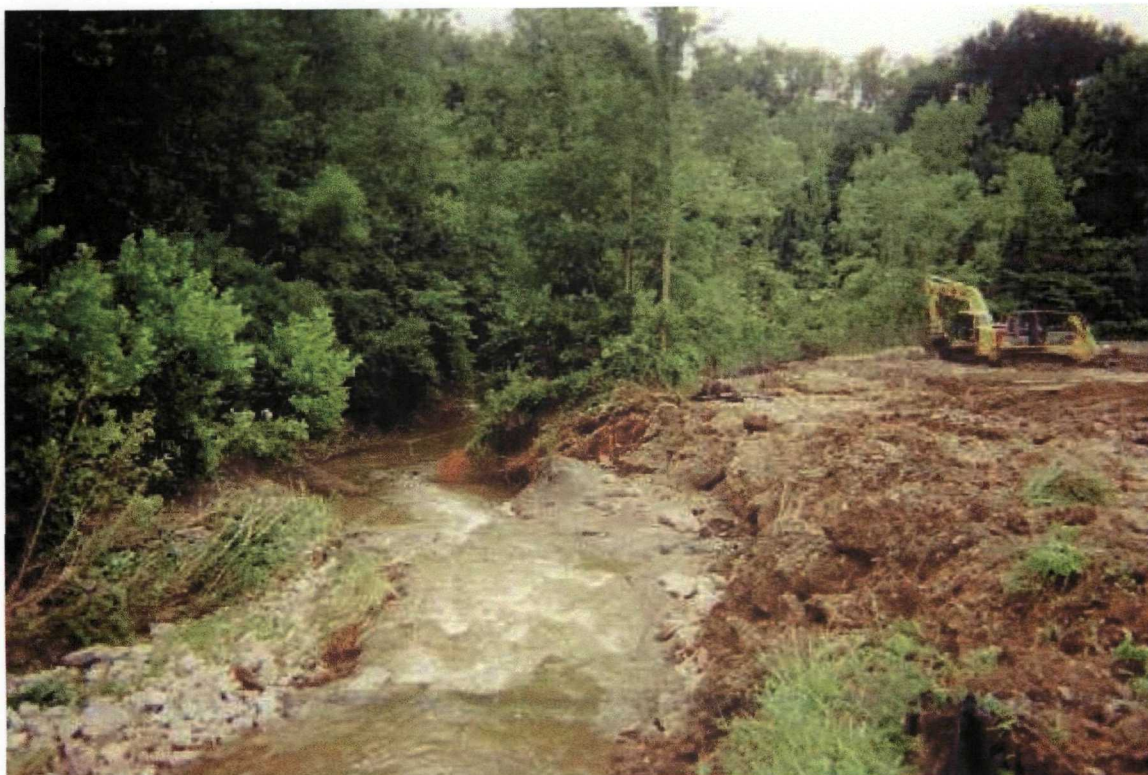
18 July 2001 - Erosion damage to cut bank along the East Fork of Mill Creek, Skinner Landfill

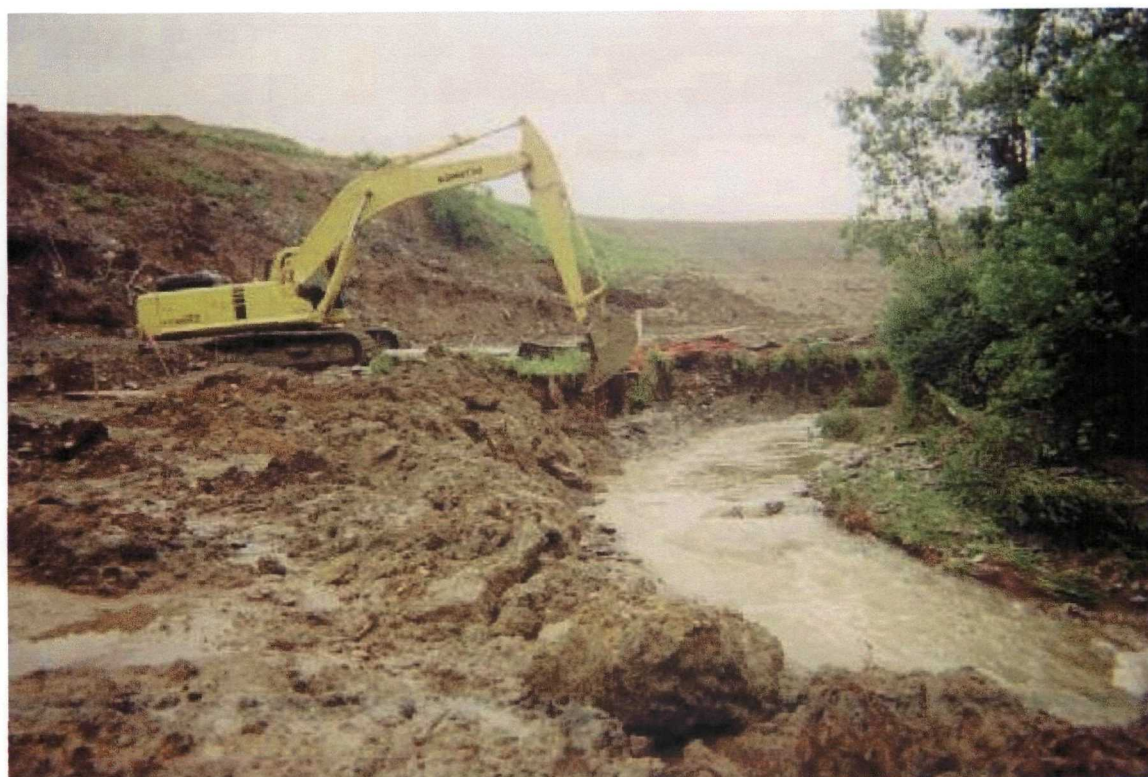
18 July 2001 - Reinforcing the creek bank after thunderstorms and erosion damage, Skinner Landfill

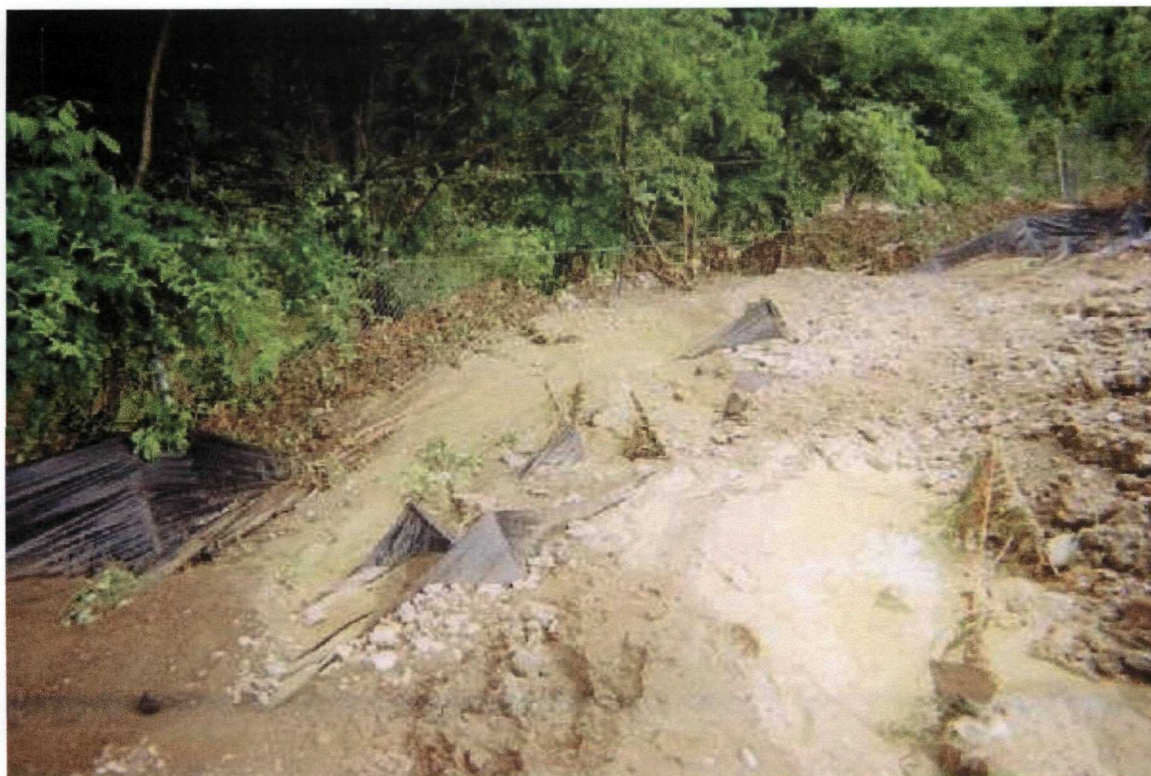
Much of the silt fence was down or buried in places along the southern perimeter of the site. And additional silt fence, hay bales, or other erosion control measures along the perimeter have yet to be implemented. Additionally, Earth Tech periodically discharged pooled run-off water and/or leachate into the East Fork of Mill Creek from a former backfill slurry mix area near the east end of the slurry wall construction. Diesel fuel, oil, or another liquid was slowly leaking from the Skinner dipper rig that was moved to access one of the two PCB soil contamination areas. The liquid was contained in a shallow pan with no secondary containment.

18 July 2001 - Silt fences partially buried from thunderstorm erosion, Skinner Landfill
